NFPA Committee on Fire Apparatus FIREFIGHTER TREAD PLATE SLIP RESISTANCE STUDY

William Marletta, Ph.D., CSP

November 3, 1999

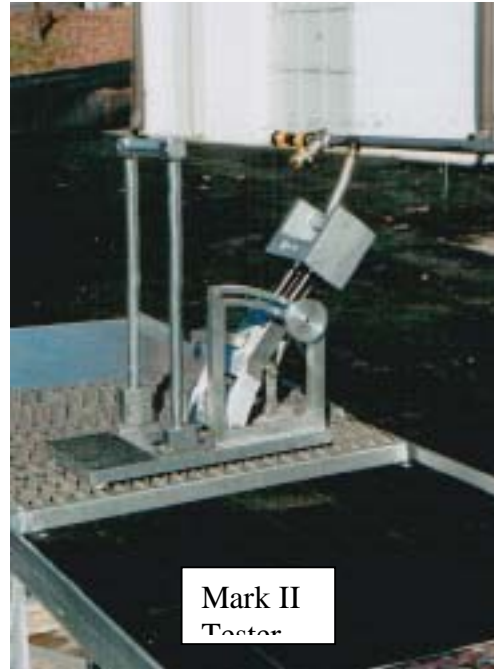
The work began in Fairfax County, Virginia as Captain Gary Pope of the Fairfax County Fire and Rescue collected suitable tread surface materials, designed a custom welded platform rig suitable to mount the surfaces at step and platform heights, and was to begin a pilot test study with firefighters. Captain Pope's efforts completed two 10' x 24" platform rigs elevated at approximately 24 inches. Captain Pope installed two steps on the side of each rig, with a handrail, to provide step type use and firefighter evaluation of the test surface materials which were inserted into the frame. In addition, the rig was outfitted with automated spray heads for maintaining the surfaces wet while firefighters walked on various surfaces and evaluated the surfaces.

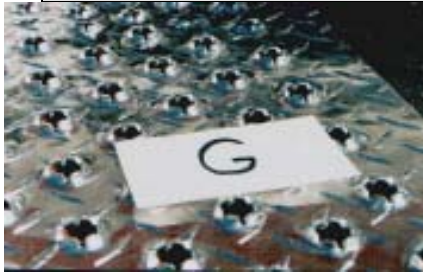
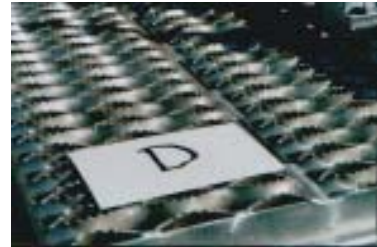
Aluminum Gator Grip, a polished diamond plate, with punched circles, identified as material "G", appeared very abrasive; however, several firefighters commented that this material could cause tripping and

expressed concern that a fall on this type of surface could cause serious injury. Surface "D" was identified as Aluminum Grip Strut, an expanded metal, open surface design.
